**NUMBER:** 08-054-05

Ambient Temperature Reads Higher Than Actual

2006 (XK) Commander

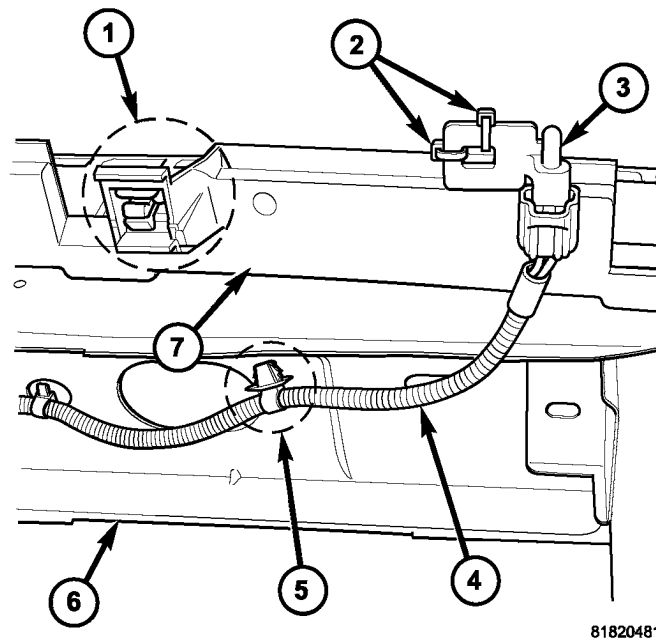
**Fig. 1 AMBIENT TEMP SENSOR HARNESS**

This condition may be caused by the original location of the ambient air temperature sensor. The sensor may be too close to the radiator and other heat exchangers.

- 1 - Original (Old) Location Of Ambient Air Temperature Sensor
- 2 - Two Plastic Tie Straps Required To Hold Sensor In Correct Position
- 3 - Ambient Air Temperature Sensor - New Location
- 4 - Ambient Air Temperature Sensor Harness
- 5 - Harness Clip - Detach (Unclip) From Front Crossmember
- 6 - Front Metal Crossmember
- 7 - Front Fascia Support Panel

3. Remove the front grill from the vehicle (Fig. 1).

4. Detach (unclip) the ambient temperature sensor from the front fascia support. The ambient temperature sensor will be relocated outboard (towards the right side) from its original location by approximately 5 inches.

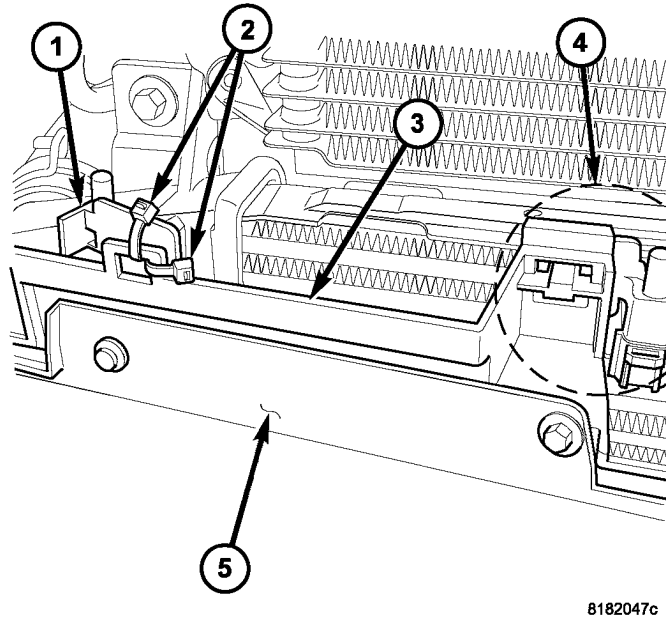
**Fig. 2 AMBIENT TEMPERATURE SENSOR**

- 1 - Ambient Temperature Sensor - New Location
- 2 - Plastic Tie Straps - Two Required. One Strap Horizontal And One Strap Vertical
- 3 - Front Fascia Support Panel
- 4 - Typical - Old Location - Detach (Unclip) Air Sensor From This Location
- 5 - Front Fascia

5. Detach the ambient temperature sensor harness plastic retainers (clip) that is closest to the ambient temperature sensor. The retainer attaches the ambient temperature sensor harness to the front bumper cross-member. The retainer must be detached to allow relocation of the ambient temperature sensor (Fig. 2).

6. Secure the ambient temperature sensor to its new location on the front fascia support. Attach the sensor to the fascia support using two plastic tie straps. The plastic tie straps must be located 90° from each other (one strap positioned horizontally, and the other strap positioned vertically). Verify that the tie straps are snug to the sensor and fascia support panel.
