**NUMBER:** 08-060-05

No Engine Crank - Loss Of Communications With Front Control Module

2006	(HB)	Durango
2006	(ND)	Dakota
2006	(WK)	Grand Cherokee
2006	(XK)	Commander

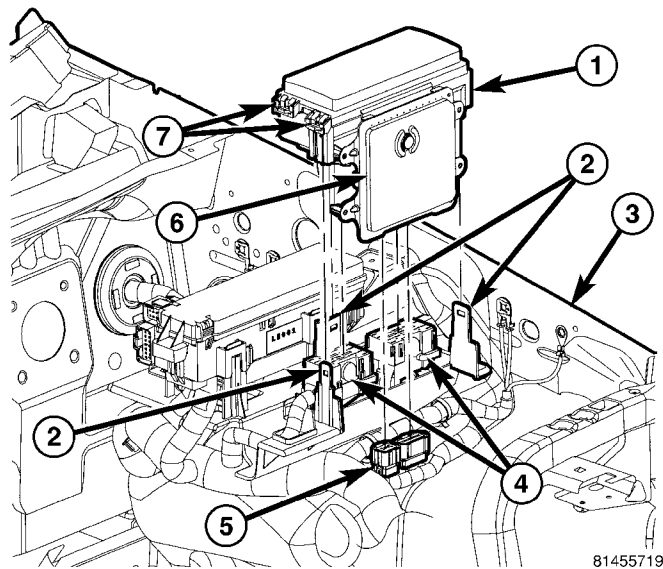
**Fig. 1 IPM REMOVAL**

- 
10. Leaving the FCM attached to the Integrated Power Module (IPM), remove the IPM from its plastic support bracket (Fig. 1).
  11. Disconnect the two 40-way electrical connectors from their electrical cavities on the back of the IPM housing. Do NOT disconnect the two electrical connectors to the FCM.
