NUMBER: 21-007-06

GROUP: Transmission

DATE: April 07, 2006

RFE Transmission Filters - Delayed Engagement And Related Transmission DTC'S

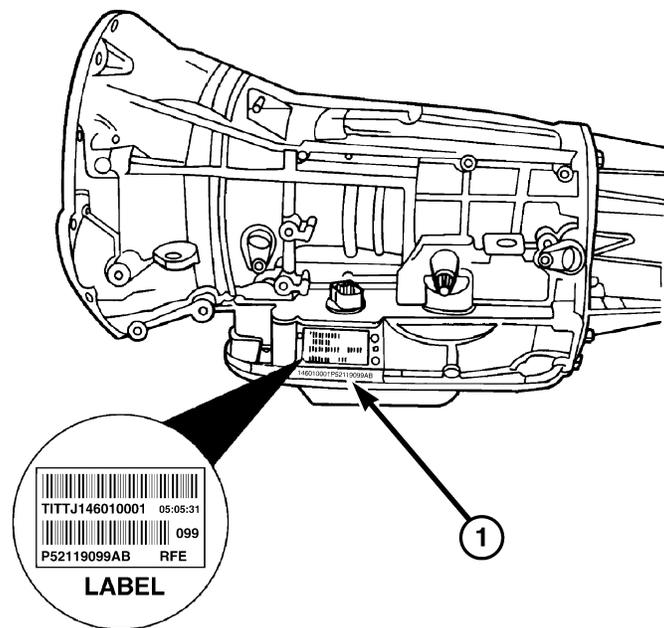
Fig. 1 TRANS IDENTIFICATION NUMBER

3. Inspect for the transmission build date (Julian date) (Fig. 1). The transmission build date can be determined by inspection of the 20 digit transmission identification number (**DDDYxxxxxP**partnumber). The transmission identification number is stamped on the left side (driver side) of the transmission oil pan flange. The first four (4) digits of the transmission identification number are the transmission build date, in Julian date format. An example of a transmission identification number would be : **101510492P52119684AA**. The first three digits (**101**) of the identification number equal the day of the year, in this case 101 equals April 11. The fourth digit (**5**) of the identification number equals the calendar year, in this case 5 equals 2005. So 1015 equals April 11, 2005.

4. Determine if the vehicle's transmission was built on or between one of the two sets of Julian date build ranges listed below:
 - a. Julian date 0425 (February 11, 2005) to Julian date 0455 (February 15, 2005). **0425 to 0455.**
 - b. Julian date 1015 (April 11, 2005) to Julian date 2345 (August 22, 2005). **1015 to 2345.**
5. If the vehicle has the above condition, and if the transmission Julian build date is on or between the range of dates listed above, perform the Repair Procedure.

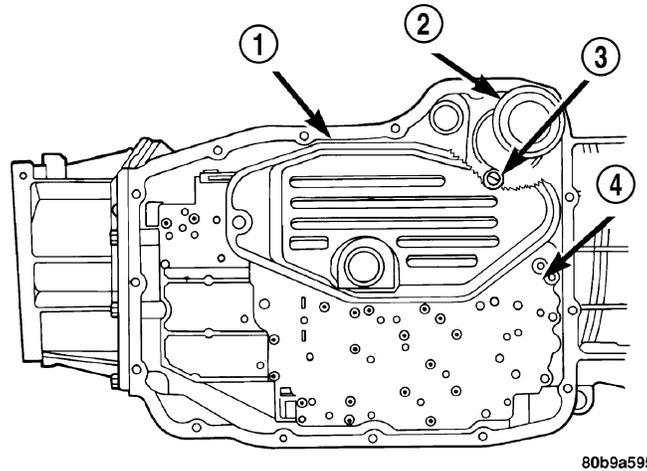
Fig. 2 Transmission Filters - 4X4 Shown

The delayed engagement and MIL condition (DTC's) may be caused by a suspect transmission cooler return filter with a part number of 04799662**AB**. A suspect **04799662AB** cooler return filter may cause the transmission sump filter to split at its plastic-to-metal crimp. If the transmission sump filter becomes split at the crimp, then one or more of the above DTC's may also occur.

NOTE: All cooler return filters with the "AB" suffix (04799662AB) are suspect. The above condition may be corrected by replacing a suspect "AB" filter with a new cooler return filter whose part number is 04799662 (with no suffix or with a suffix that is other than the "AB" level), and a new sump filter.

NOTE: BOTH the sump oil filter and the cooler return filter MUST BE replaced in the transmission at the same time. Do not replace one filter without also replacing the other filter.

NOTE: A replacement 04799662 cooler return filter may come packaged with a separate threaded adapter stud. The threaded adapter stud is used to attach the cooler return filter to the transmission. Inspect the stud and note end without threads. Install the stud end without the threads into the cooler return filter and tighten the stud-to-filter connection to 18.6 Nm (165 in. lbs.). Once the threaded adapter stud has been installed to the cooler return filter, install the assembled cooler return filter to the transmission and tighten the filter to 14.1 Nm (125 in. lbs.)

Use the procedures outlined in TechCONNECT® (Service Information Tab / 21 - Transmission Transaxle / Automatic - 45RFE 545RFE / Fluid / Standard Procedure / Fluid and Filter Replacement) to replace **BOTH** the transmission cooler return filter and the transmission sump oil filter.

NOTE: Always install the sump filter seal to the bottom of the transmission oil pump first, then install the sump filter to the oil pump and previously installed seal. **DO NOT** install the sump filter seal to the sump filter and then attempt to install both to the oil pump.
