NUMBER: 21-015-05

45RFE / 545RFE Trans - Delayed Engagement Due To Cooler Return Filter Replacement

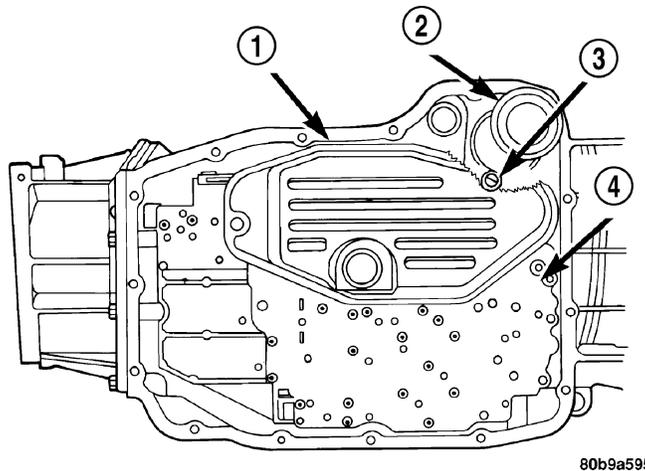
Fig. 1 Transmission Filters - 4X4 Shown

The above condition may be caused by a suspect cooler return filter a part number of **04799662AB**. This “**AB**” suffix / level filter may allow transmission fluid to drain back out of the torque converter. The drain back condition may occur over a period time when the

engine (and transmission) are not running. With less fluid in the torque converter a delay in gear engagement may occur at engine start up while the torque converter fills to its proper fluid level.

All 04799662AB cooler return filters with the "AB" suffix are suspect. The above condition may be corrected by replacing a suspect "AB" filter with a new cooler return filter whose part number is 04799662 (with no suffix or with a suffix that is other than the "AB" level).

NOTE: A replacement 04799662 cooler return filter may come packaged with a separate threaded adapter stud. The threaded adapter stud is used to attach the cooler return filter to the transmission. Inspect the stud and note end without threads. Install the stud end without the threads into the cooler return filter and tighten the stud-to-filter connection to 18.6 Nm (165 in. lbs.). Once the threaded adapter stud has been installed to the cooler return filter, install the assembled cooler return filter to the transmission and tighten the filter to 14.1 Nm (125 in. lbs.)
