**NUMBER:** 23-004-08

**DATE:** January 16, 2008

Ratcheting Sound During Sunroof Operation

This bulletin involves replacing the sunroof drive cable conduit.

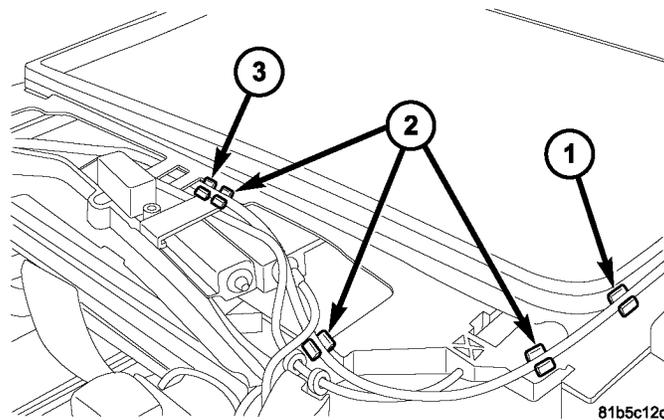
**Fig. 1 CONDUIT RETENTION**

- 1 - CLIP END
- 2 - RETAINING FEATURES
- 3 - MOTOR END

1. Ensure the sunroof module is in the full closed position.
2. Remove M6 mounting bolts (4) at rear portion of sunroof module.
3. Remove the kinked cable conduit(s) from sunroof module retaining features starting from the end at the metal clip and work back to motor area, see (Fig. 1).

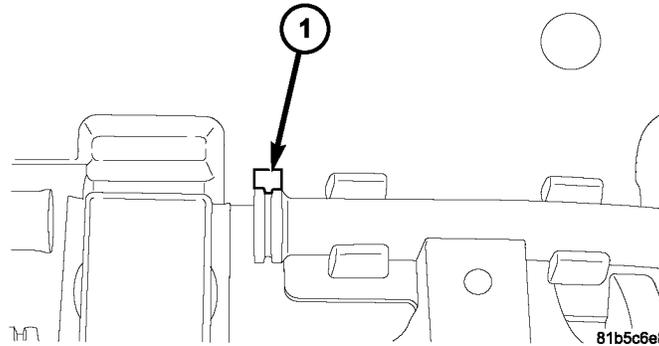
**Fig. 2 CONDUIT FLARE INTO NOTCH**

1 - LOCATE CONDUIT FLARE INTO NOTCH

- 
4. Assemble new cable conduit, p/n 68003812AA, in reverse order of [Step #3](#)) by inserting the flared end over the exposed end of the drive cable. Insure the flared end is sitting in the notch on the rear bulk head of sunroof module, ([Fig. 2](#)).

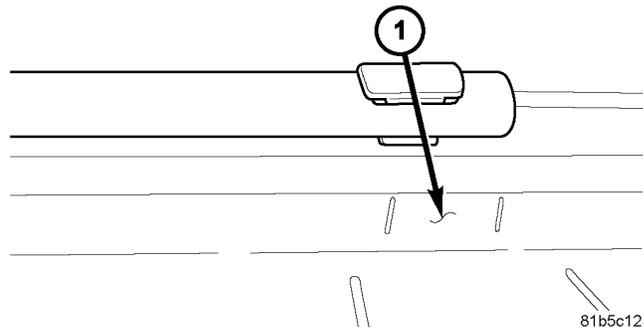
**Fig. 3 CLIP TO ALUMINUM GUIDE LOCATION**

1 - ENSURE CLIP IS POSITIONED BETWEEN MARKS

5. Snap the cable conduit into the retaining features in the rear bulk head (5 places) with the end of the tube retained in spring clip on the aluminum guide. Ensure the clip is within the provided scribe lines on aluminum guide, (Fig. 3).

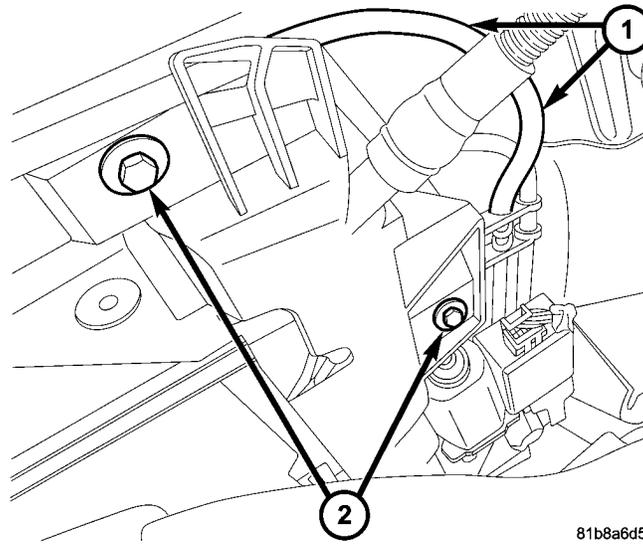
**Fig. 4 KINK LOCATION**

1. Put the sunroof in the closed or vent position.
2. Drop headliner right front corner, by removing the right side A-pillar trim, B-pillar trim sun visor, sun visor clip and rear view mirror.
3. Look at and/or feel the drive cable conduit in the radius above the drain hose this is where the conduit will be kinked.
4. Remove 2 sunroof mounting fasteners, (Fig. 4).

- 1 - KINK LOCATION
  - 2 - MOUNTING FASTENERS
-

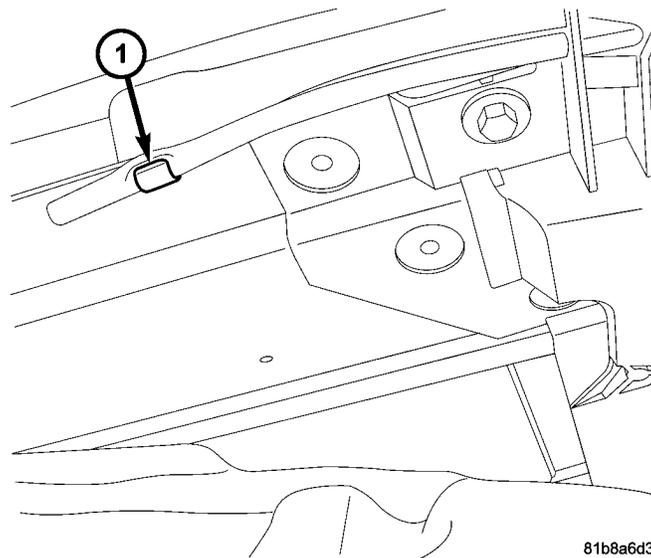
**Fig. 5 CONDUIT RETAINER CLIP**

- 1 - CLIP
-

5. Remove conduit from clip at side of sunroof module, (Fig. 5).

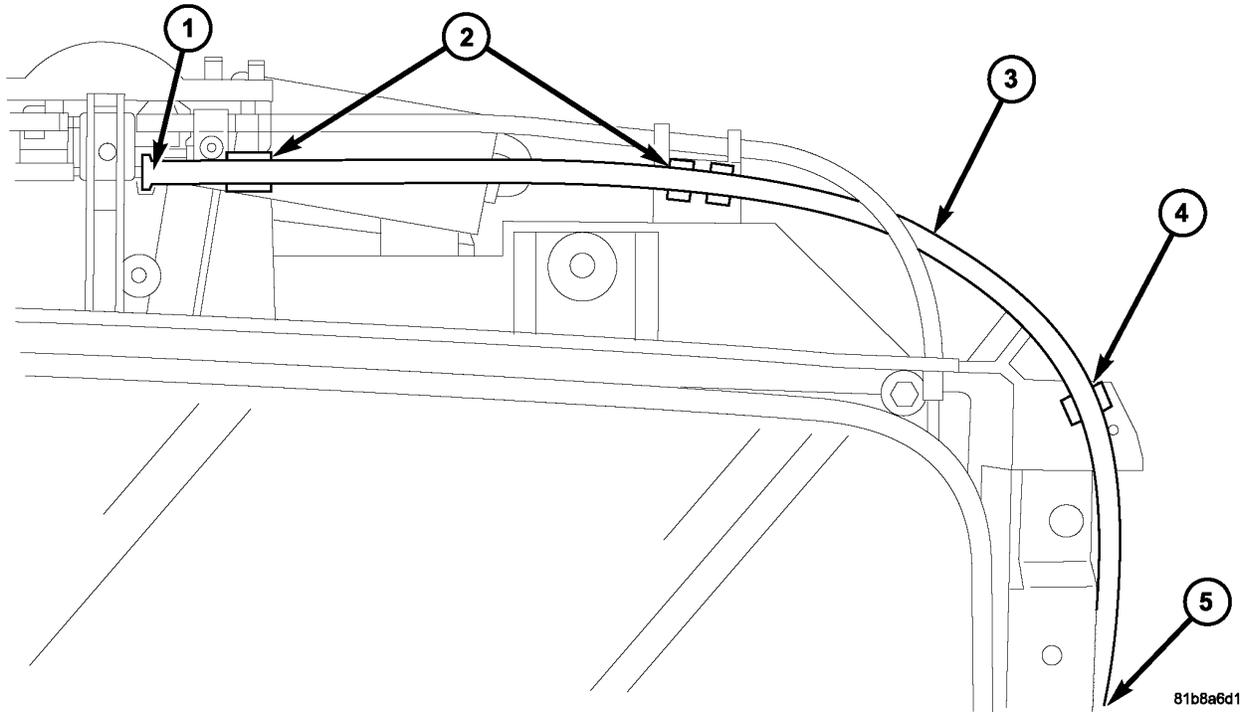
**Fig. 6 CONDUIT ROUTING/RETENTION**

- 1 - CONDUIT IN NOTCH
- 2 - RETENTION FEATURES
- 3 - CONDUIT
- 4 - FRONT BEAM RETENTION FEATURE
- 5 - CONDUIT CLIP (OUT OF VIEW)

6. Push the conduit up and inboard to release it from the retention feature on the front beam, (Fig. 6) item 4.

- 
- 7. Push the conduit up to release it from the additional retention features, (Fig. 6) item 2.
  - 8. Pull the conduit out from over/off the drive cable.
  - 9. Slide the new conduit, p/n 68003816AA, back over the drive cable. See (Fig. 6) item 1, to ensure conduit is seated into notch to the rear of the steel drive cable tube.
  - 10. Secure the conduit in the retention features shown in (Fig. 6).
  - 11. Install the conduit in the side clip.
  - 12. Operate the sunroof to ensure the ratcheting noise is eliminated.
  - 13. Install the mounting bolts.
  - 14. Install the headliner, A-pillar trim, sun visor and visor clip.
