**NUMBER:** 23-039-06

Passenger Seat Manual Recliner Inoperative

2006 - 2007	(WK)	Grand Cherokee
2006 - 2007	(XK)	Commander

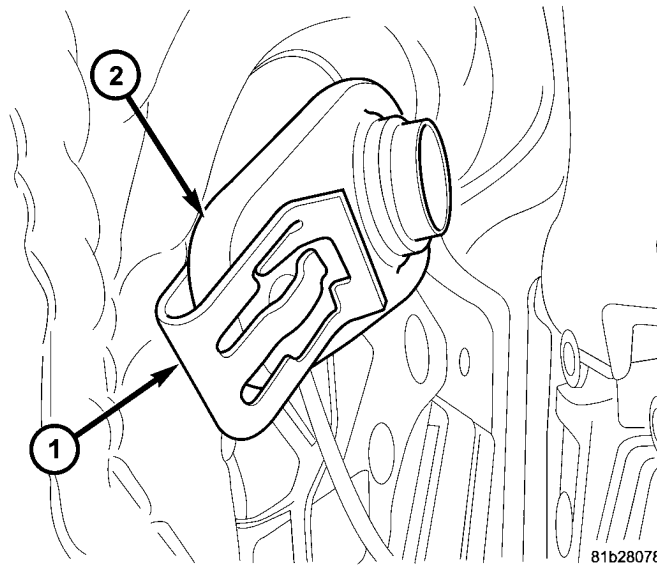
The passenger seat manual recliner is inoperative because the cable has detached from the recliner bell crank.

**Fig. 1 CLIP PROPERLY INSTALLED**

- 1 - CLIP
- 2 - BELL CRANK

8. Push the clip on to the bell crank, (Fig. 1). If the clip is not fully seated on the bell crank, tap the clip the rest of the way on with a small mallet.
