NUMBER: 23-039-06

Passenger Seat Manual Recliner Inoperative

2006 - 2007	(WK)	Grand Cherokee
2006 - 2007	(XK)	Commander

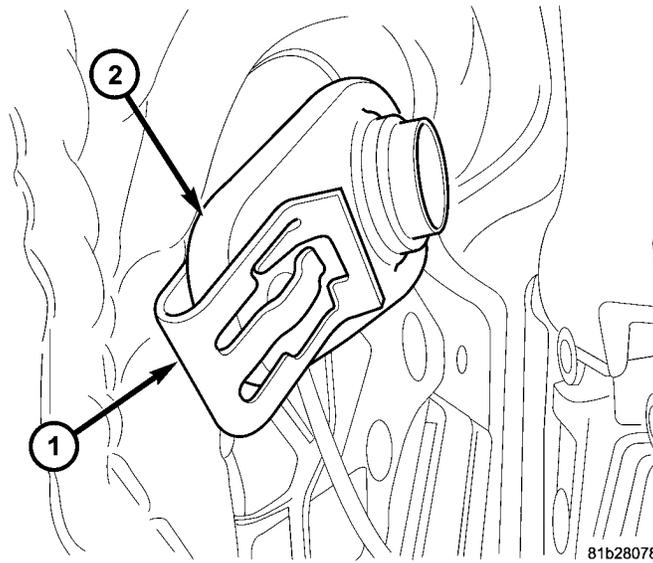
Fig. 1 CLIP PROPERLY INSTALLED

The passenger seat manual recliner is inoperative because the cable has detached from the recliner bell crank.

8. Push the clip on to the bell crank, (Fig. 1). If the clip is not fully seated on the bell crank, tap the clip the rest of the way on with a small mallet.
