Second Row 40/20/40 Fold & Tumble Seat Mechanism Binding

This bulletin involves adjusting the tumble mechanism on one or both 40% second row seats as necessary.

Commander

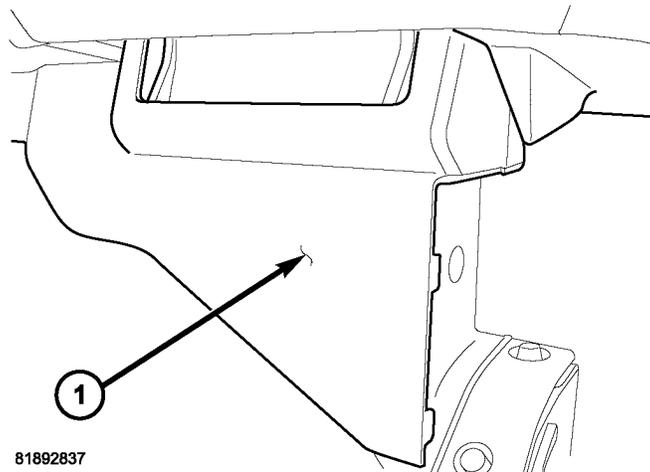
**Fig. 2 FRONT TUMBLE MECHANISM SHIELD**

1 - FRONT TUMBLE MECHANISM SHIELD

1. Remove the trim cover end cap (Fig. 1).
2. Remove the front tumble mechanism shield (Fig. 2).

12. Install the front tumble mechanism shield (Fig. 2).
13. Install the trim cover end cap (Fig. 1).
14. If necessary, repeat [Step #1](#) through [Step #13](#) on the other second row 40% seat.

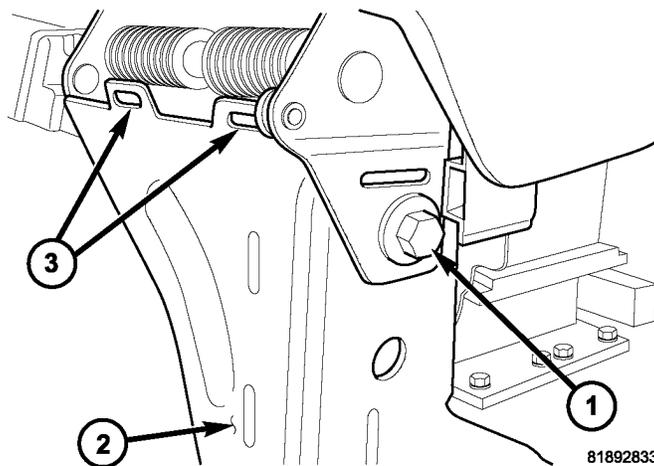
**Fig. 3 OUTBOARD TUMBLE MECHANISM BOLT**

1 - OUTBOARD TUMBLE MECHANISM BOLT  
 2 - FORWARD SEAT LEG  
 3 - NOTE TAB POSITIONS

3. Note the position of the two tabs (fore and aft) on the forward seat leg (Fig. 3).
4. Make sure the seat is in the fold flat position with the latches engaged. Loosen the outboard tumble mechanism bolt (Fig. 3).

8. Have the tabs on the forward seat leg moved from their original position as illustrated in ([Fig. 3](#))?
  - a. Yes >> go to [Step #9](#).
  - b. No >> Repeat [Step #5](#) through [Step #8](#).

9. Tighten the underside tumble mechanism bolt to 34 N·m (25 ft. lbs.) ([Fig. 4](#)).
10. Tighten the outboard tumble mechanism bolt to 34 N·m (25 ft. lbs.) ([Fig. 3](#)).

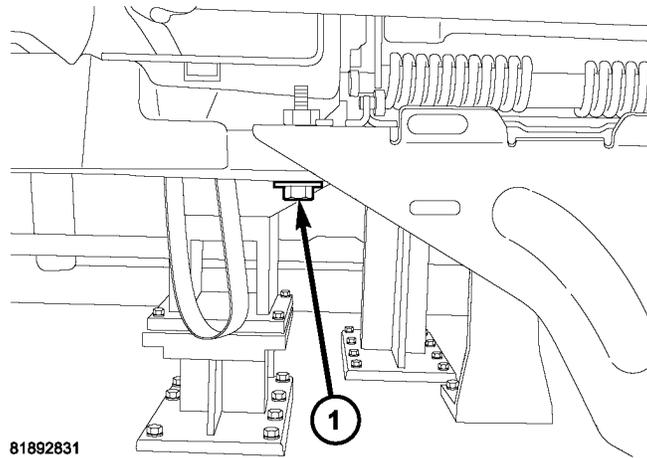
**Fig. 4 UNDERSIDE TUMBLE MECHANISM BOLT**

1 - UNDERSIDE TUMBLE MECHANISM BOLT

5. Loosen the underside tumble mechanism bolt (Fig. 4)
