**SUBJECT:** RAPID RESPONSE TRANSMITTAL SERVICE ACTION # 06-030  
Cowl Stud Sealing Patch

**INVOLVED VEHICLES:** 2006 (XK) Commander

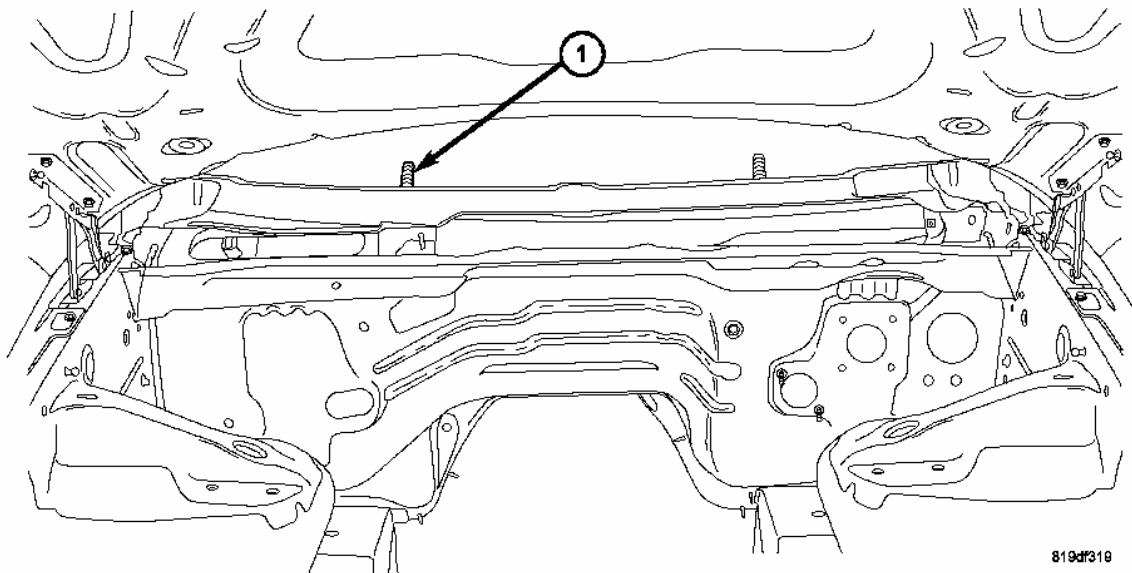
819df319

A number of vehicles may have been shipped with a cowl stud sealing patch that is not completely adhered.

1. INSPECT HEAD OF STUD INSIDE COWL PLENUM FOR SEALING PATCH

4. There should be a 38 mm x 38 mm (1.5 in. x 1.5 in.) 1 mm (.040 in.) thick mastic patch inside the cowl plenum over the head of this stud.
5. If patch is hanging, secure existing patch by pressurizing over stud head. If patch is fully adhered, no additional action required.
6. If patch is missing, apply patch, p/n 04278178, over the head of the stud.
7. Locate the missing patch within the plenum/HVAC area and discard.
8. Install the cowl screen.
9. With the wiper motor in the park position, install the windshield wiper arms so that the lower edge of the blade is aligned with the wiper alignment lines concealed in the upper margin of the lower windshield blackout area. Tighten the nuts to 21 N·m (16 ft. lbs.).
